#### **TECHNICAL REPORT ARCCB-TR-98018**

# COMPREHENSIVE EROSION MODEL FOR THE 120-MM M256/M829A2 GUN SYSTEM

**OCTOBER 1998**

### US ARMY ARMAMENT RESEARCH, DEVELOPMENT AND ENGINEERING CENTER

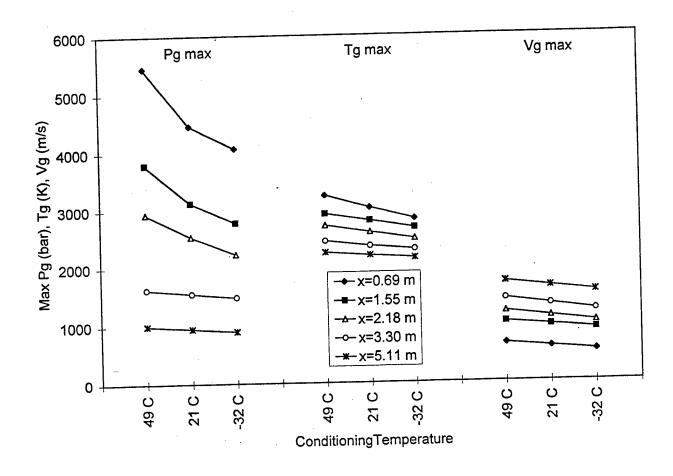
Figure 1 summarizes the M829A2 XNOVAKTC interior ballistic analysis for maximum values of gas pressure ( $P_g$ ), gas temperature ( $T_g$ ), and gas velocity ( $V_g$ ) as a function of axial position and round-conditioning temperature. Maximum values were used instead of time-dependent data to simplify the appearance of this figure. Selected axial positions included 0.69, 1.55, 2.18, 3.30, and 5.11 meters from the rear face of the tube (RFT), while the selected round-conditioning included hot (49°C), ambient (21°C), and cold (-31°C) temperatures. (These five selected axial positions and three selected round-conditioning temperatures will be used exclusively for the rest of the figures in this report). Experimental pressure-time and muzzle velocity data were used to calibrate the interior ballistic analysis. In Figure 1, the  $T_g$  and  $P_g$  values decrease with increasing axial position, while the  $V_g$  values increase with increasing axial position for the bore region.

Figure 1. M829A2 calibrated XNOVAKTC interior ballistic analysis for maximum values of gas pressure, gas temperature, and gas velocity.

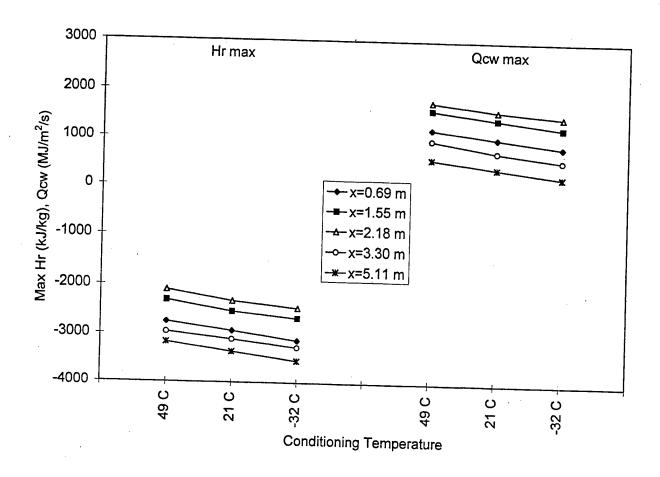
Figure 2 summarizes the M829A2 MABL analysis for maximum values of recovery enthalpy  $(H_r)$  and cold wall heat flux  $(Q_{cw})$  as a function of the selected axial positions and round-conditioning temperatures. Maximum values were also used instead of time-dependent data to simplify the appearance of this figure. Experimental thermal repacking depth away from cracks, thermal transformation depth away from cracks, and thermocouple data were used to calibrate this improved boundary layer analysis. The figure illustrates that  $H_r$  and  $Q_{cw}$  values increase with increasing axial position for the 0.6 to 1.2 meter from RFT region; both values peak in the 1.2 to 2.4 meter range; then both values decrease with increasing axial position to the muzzle. Note that the heat transfer pattern in Figure 2 significantly differs from the core flow pattern in Figure 1 and cannot be explained solely on the basis of simple heat transmission (film) coefficient effects (ref 5). We theorize that this difference can be explained by an improved boundary layer analysis, including significant combustion case gas cooling effects and these significant turbulent gas mixing/heating effects.

Figure 2. M829A2 calibrated MABL analysis for maximum values of recovery enthalpy and cold wall heat flux.

Figures 7 through 9 show that wall temperature profiles follow the positional order of the heat transfer pattern from Figure 2. In these three figures, maximum values were used instead of time-dependent data to simplify their appearance. Also, experimental thermal repacking depth away from cracks, thermal transformation depth away from cracks, and thermocouple data were used to calibrate calculated wall temperature profiles.

Figures 10 through 13 show that cumulative wall erosion profiles also follow the positional order of the heat transfer pattern from Figure 2. Erosion life is lowest at 2.18 meters, higher at 1.55 meters, still higher at 0.69 meter, higher yet at 3.30 meters, and highest at 5.11 meters from RFT. Additionally, these four figures show that interface life follows this same pattern with the exception of the 5.11 meter position, which is believed to be by a different mechanism.

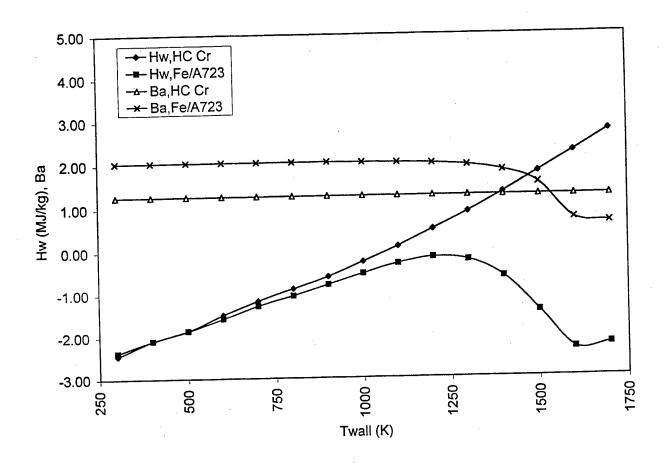
Figure 3 summarizes the M829A2 CCET thermochemical analysis of reacting wall enthalpy (H<sub>w</sub>) and ablation potential (B<sub>a</sub>) (ref 3) as a function of the wall temperatures (T<sub>wall</sub>) for high contraction (HC) chromium plate/A723 gun steel wall materials. Experimental kinetic rate function data and subsurface metallographic data were used to calibrate the thermochemical analysis and transform the chemical equilibrium analysis into a partial chemical kinetic analysis. The HC chromium maximum T<sub>wall</sub> is about 1650°K for the M256/M829A2 gun system. This is below its passivating oxidation temperature at about 2000°K, and well below its melting point at about 2130°K, which explains its inertness. The A723/iron maximum T<sub>wall</sub> is about 1400°K for the M256/M829A2 gun system. This is well above its rapid expansive flaking oxidation temperature at about 1055°K, explaining its reactivity. In addition, it is below its iron oxide melting point at about 1640°K and well below its A723/iron melting point at about 1810°K.

Figure 3. M829A2 calibrated CCET thermochemical analysis of reacting wall enthalpy and ablation potential.

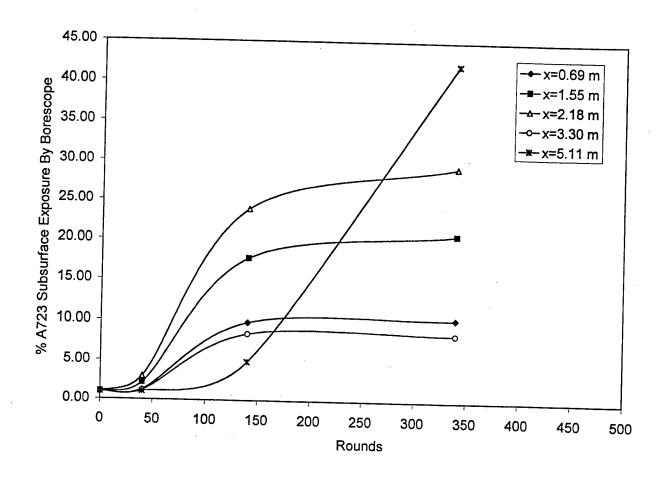
Figure 4 summarizes the M829A2 borescope data analysis of the A723 subsurface exposure through HC chromium plate cracks as a function of rounds fired for selected axial positions. The experimental borescope data was used to calibrate erosion analysis. This data was collected on a cleaned M256 tube that had about half M829A2 and half M829 rounds. These M829A2 and M829 rounds consisted of a nearly equal distribution of hot/ambient/cold temperature conditioning. Data collection involved the use of a magnifying borescope with a calibrated scale to measure the number and average area of each HC chromium platelet within a designated total area as a function of axial position for a given round count.

Figure 4. M829A2 borescope data analysis of the A723 subsurface exposure through HC chromium plate cracks.

For the selected axial positions in Figure 4, from 50 to 100 rounds, the A723 subsurface exposure rose rapidly due to HC chromium thermal repacking, nonmetallic out-gassing, and possibly compression resulting in its shrinkage and heat checking. After about 100 rounds, the above mechanism diminished and A723 subsurface exposure rose more slowly because only the HC chromium platelet spalling mechanism remained. At the 5.11 meter from RFT near-muzzle position, the A723 subsurface exposure rose very rapidly from about 100 rounds until its out-of-service round count due to HC chromium platelet spalling by a different purely mechanical mechanism. This tube was taken out-of-service due to dispersion at about seventy percent of its estimated erosion life possibly because of the typical severe muzzle wear.

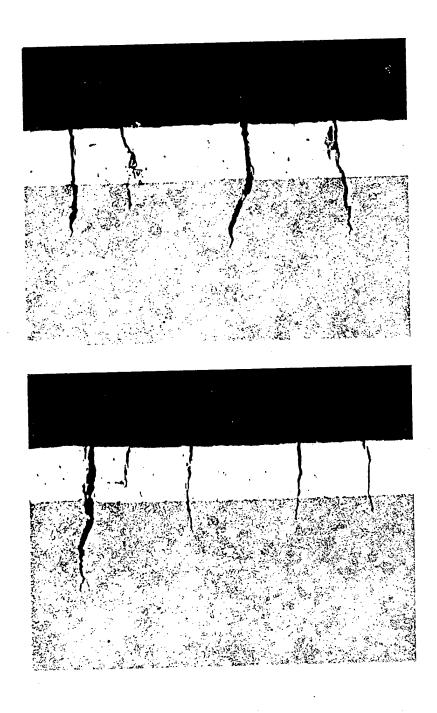
Figure 5 presents two typical 100x metallographs of an M256 tube with about half M829A2 and half M829 rounds at 0.69 meter from RFT. This represents the 0.6 to 1.2 meter region and was used to calibrate the erosion analysis. The 0.6 to 1.2 meter region has the highest gas pressure of any bore region (Figure 1), which explains the deep crack depths due to severe dilation. Although this 0.6 to 1.2 meter region has the highest gas temperature of any bore region (Figure 1), heat transfer to the wall is significantly diminished due to combustion case gas cooling effects (Figure 2). These observations explain the heat checking and crack spacing as well as the near absence of interface degradation and chromium platelet spalling.

Figure 5. Tube #1988 metallographs at 0.69 meter representing 0.6 to 1.2 meters from RFT region (100x).

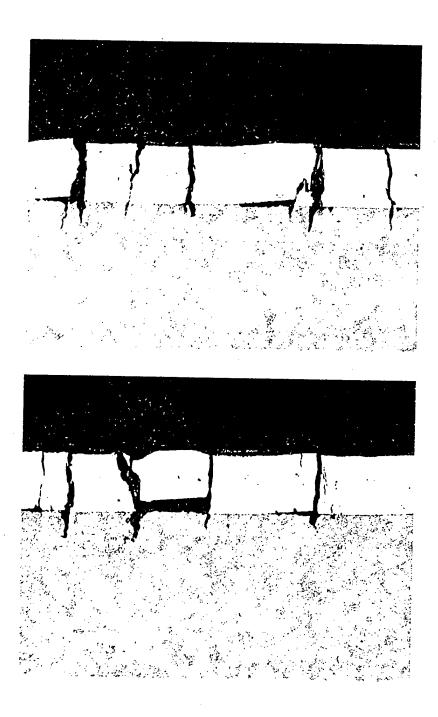
Figure 6 presents two typical 100x metallographs of an M256 tube with about half M829A2 and half M829 rounds at 1.55 meters from RFT. This represents the 1.2 to 2.4 meter region and was also used to calibrate the erosion analysis. The 1.2 to 2.4 meter region has a lower gas pressure than the 0.6 to 1.2 meter region (Figure 1), which explains the moderate crack depths due to moderate dilation. Although this 1.2 to 2.4 meter region has a lower gas temperature than the 0.6 to 1.2 meter bore region (Figure 1), heat transfer to the wall is significantly higher due to turbulent gas mixing (Figure 2). These observations explain the heat checking and crack spacing as well as the prevalent interface degradation and chromium platelet spalling. We theorize that the main gun erosion mechanism consists of inert chromium plate cracking, shrinkage, and heat checking, followed by subsequent interfacial degradation of the subsurface gun steel substrate at the chromium crack bases, subsequent chromium platelet spalling, and subsequent bare gun steel gas wash. The gun steel at the chromium/gun steel interface is more susceptible to interface degradation than either of its components separately due to its higher energy state and reactivity. In addition, interface degradation is enhanced by expansive flaking of iron oxide.

Figure 6. Tube #1988 metallographs at 1.55 meters representing 1.2 to 2.4 meter region (100x).

As chromium platelets detach from the substrate and rise above attached chromium platelets, they are more susceptible to mechanical removal by the projectile. In addition, the 1.2 to 2.4 meter region has a wavy chromium surface appearance in cross-section due to partially detached chromium platelets. Rarely do radial heat-checking cracks link-up to spall a chromium platelet with attached gun steel. Although there appears to be evidence of heat-checking cracks extending into the wall well beyond the heat-affected zone due to environmental-assisted cracking, great scrutiny has produced no measurable evidence of chromium platelet spalling due to cracking in the plane of the chromium plate/gun steel interface.

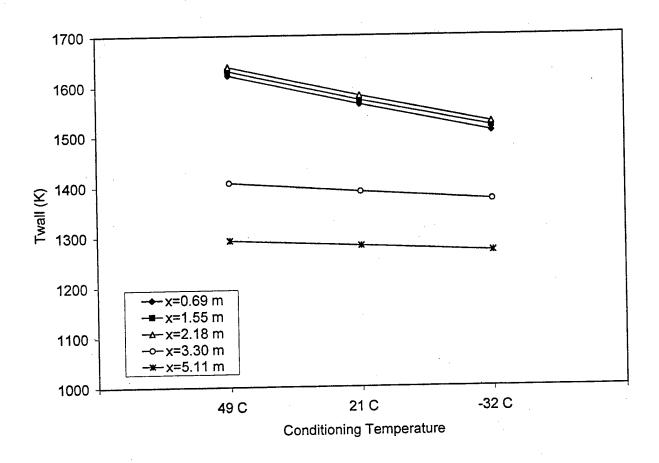
Figure 7 shows the M256/M829A2 MACE wall temperature profile analysis for HC chromium maximum surface temperature ( $T_{wall}$ ) as a function of round-conditioning temperatures for selected axial positions. The HC chromium maximum  $T_{wall}$  is about 1650°K, which is below its passivating oxidation temperature at about 2000°K, and well below its melting point at about 2130°K, thus explaining its inertness.

Figure 7. M256/M829A2 calibrated MACE wall temperature profile analysis for HC chromium maximum surface temperature.

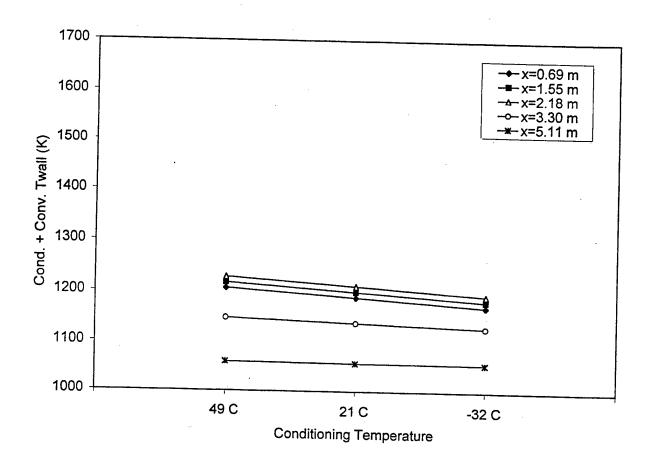
Figure 8 shows the M256/M829A2 MACE wall temperature profile analysis for A723 maximum interface wall temperature (T<sub>wall</sub>) as a function of round-conditioning temperatures for selected axial positions. The T<sub>wall</sub> values are a combination of convection and conduction at the crack walls. The A723/iron maximum interface T<sub>wall</sub> is about 1250°K, which is above its rapid expansive flaking oxidation temperature at about 1055°K, explaining its reactivity. In addition, it is below its iron oxide melting point at about 1640°K and well below its A723/iron melting point at about 1810°K. Diffusion, reactions, transformations, and gas wash thermochemically degrade interfacial A723 at HC chromium plate heat-checked crack bases.

Figure 8. M256/M829A2 calibrated MACE wall temperature profile analysis for A723 maximum interface wall temperature.

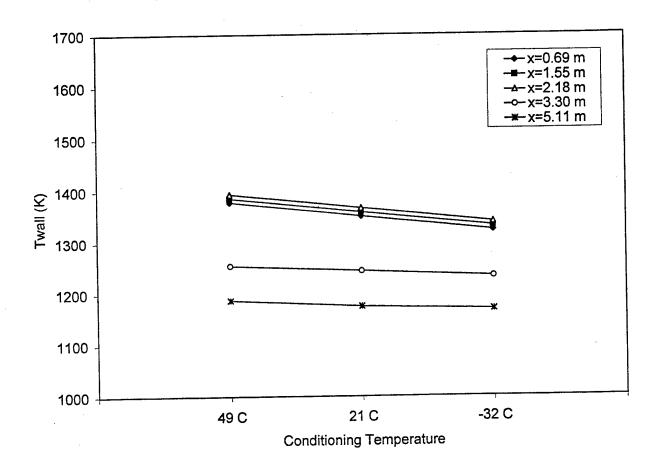
Figure 9 shows the M256/M829A2 MACE wall temperature profile analysis for A723 maximum surface wall temperature ( $T_{wall}$ ) as a function of round-conditioning temperatures for selected axial positions. The A723/iron maximum surface  $T_{wall}$  is about 1400°K, which is well above its rapid expansive flaking oxidation temperature at about 1055°K, explaining its reactivity. In addition, it is below its iron oxide melting point at about 1640°K and well below its A723/iron melting point at about 1810°K. Diffusion, reactions, transformations, and gas wash thermochemically degrade fully exposed surface A723 after HC chromium plate spalling.

Figure 9. M256/M829A2 calibrated MACE wall temperature profile analysis for A723 maximum surface wall temperature.

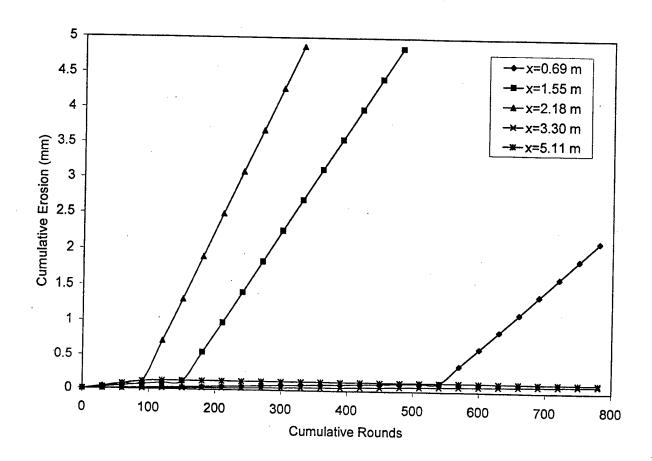
Figure 10 summarizes the M256/M829A2 MACE cumulative erosion analysis for the unrealistic, but informative case of only 49°C conditioned rounds as a function of cumulative rounds for selected axial positions. The figure shows the 2.18 meter axial position to be the most eroded position. It takes about 100 rounds for chromium platelet spalling onset/gun steel gas wash onset to occur. It takes about 340 rounds to achieve the 5 mm of cumulative erosion required to condemn this gun on erosion, and it takes about 250 rounds to achieve about 3 mm of cumulative erosion typical of the erosion damage when this gun is taken out-of-service for excessive dispersion at about seventy percent of its erosion life.

Figure 10. M256/M829A2 MACE cumulative erosion analysis for the unrealistic, but informative case of only 49°C conditioned rounds.

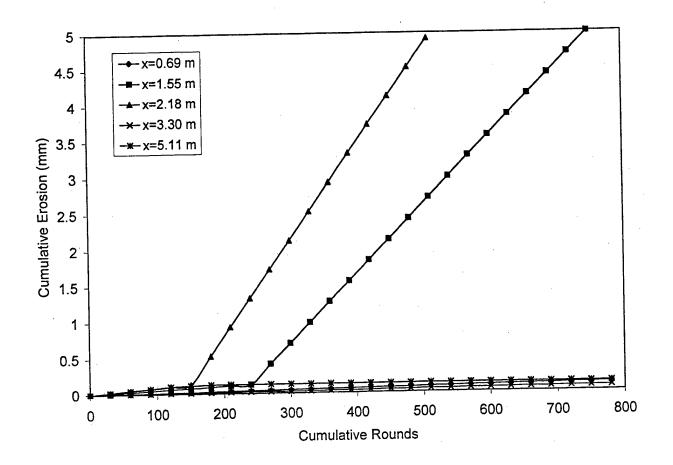
Figure 11 summarizes the M256/M829A2 MACE cumulative erosion analysis for the unrealistic, but informative case of only 21°C conditioned rounds as a function of cumulative rounds for selected axial positions. The figure shows the 2.18 meter axial position to be the most eroded position. It takes about 150 rounds for chromium platelet spalling onset/gun steel gas wash onset to occur. It takes about 510 rounds to achieve the 5 mm of cumulative erosion required to condemn this gun on erosion, and it takes about 380 rounds to achieve about 3 mm of cumulative erosion typical of the erosion damage when this gun is taken out-of-service for excessive dispersion at about seventy percent of its erosion life.

Figure 11. M256/M829A2 MACE cumulative erosion analysis for the unrealistic, but informative case of only 21°C conditioned rounds.

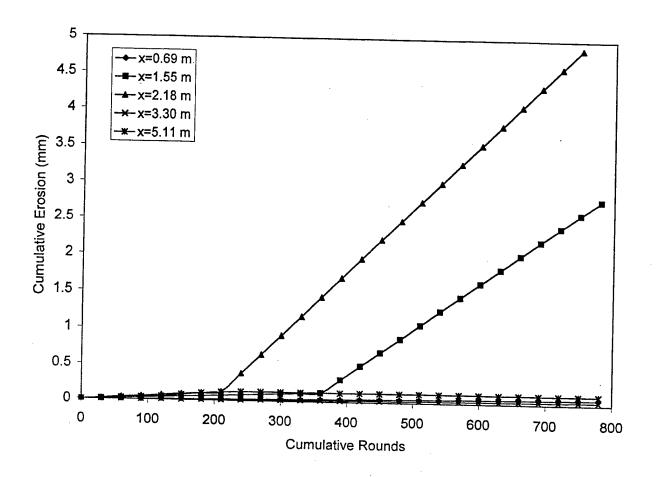
Figure 12 summarizes the M256/M829A2 MACE cumulative erosion analysis for the unrealistic, but informative case of only -32°C conditioned rounds as a function of cumulative rounds for selected axial positions. The figure shows the 2.18 meter axial position to be the most eroded position. It takes about 210 rounds for chromium platelet spalling onset/gun steel gas wash onset to occur. It takes about 770 rounds to achieve the 5 mm of cumulative erosion required to condemn this gun on erosion, and it takes about 560 rounds to achieve about 3 mm of cumulative erosion typical of the erosion damage when this gun is taken out-of-service for excessive dispersion at about seventy percent of its erosion life.

Figure 12. M256/M829A2 MACE cumulative erosion analysis for the unrealistic, but informative case of only -32°C conditioned rounds.

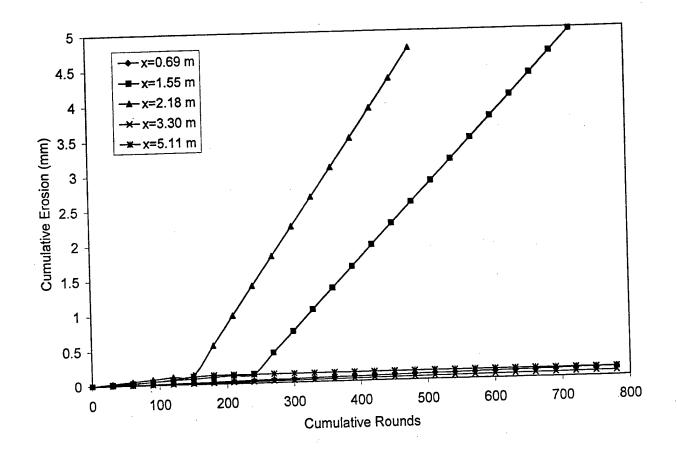
Figure 13 summarizes the M256/M829A2 MACE cumulative erosion analysis for the semi-realistic and informative case of an equal distribution of hot/ambient/cold-conditioned rounds as a function of cumulative rounds for selected axial positions. This figure also shows the 2.18 meter axial position to be the most eroded position. It takes about 150 rounds for chromium platelet spalling onset/gun steel gas wash onset to occur. It takes about 480 rounds to achieve the 5 mm of cumulative erosion required to condemn this gun on erosion, and it takes about 350 rounds to achieve about 3 mm of cumulative erosion typical of the erosion damage when this gun is taken out-of-service for excessive dispersion at about seventy percent of its erosion life.

Figure 13. M256/M829A2 MACE cumulative erosion analysis for the semi-realistic and informative case of an equal distribution of hot/ambient/cold-conditioned rounds.
